DEPARTMENT OF TRANSPORTATION**DIVISION OF ENGINEERING SERVICES**

Quality Assurance and Source Inspection

Contract #: 04-0120F4Cty: SF/ALA Rte: 80 PM: 13.2/13.9File #: 69.28**WELDING INSPECTION REPORT****Resident Engineer:** Siegenthaler, Peter**Address:** 333 Burma Road**City:** Oakland, CA 94607**Report No:** WIR-019730**Date Inspected:** 10-Jan-2011**Project Name:** SAS Superstructure**OSM Arrival Time:** 700**Prime Contractor:** American Bridge/Fluor Enterprises, a JV**OSM Departure Time:** 1900**Contractor:** Zhenhua Port Machinery Company, Ltd (ZPMC), Changxing Island **Location:** Shanghai, China**CWI Name:** Qiu Wen.**CWI Present:** Yes No**Inspected CWI report:** Yes No N/A**Rod Oven in Use:** Yes No N/A**Electrode to specification:** Yes No N/A**Weld Procedures Followed:** Yes No N/A**Qualified Welders:** Yes No N/A**Verified Joint Fit-up:** Yes No N/A**Approved Drawings:** Yes No N/A**Approved WPS:** Yes No N/A**Delayed / Cancelled:** Yes No N/A**Bridge No:** 34-0006**Component:** OBG components.**Summary of Items Observed:**

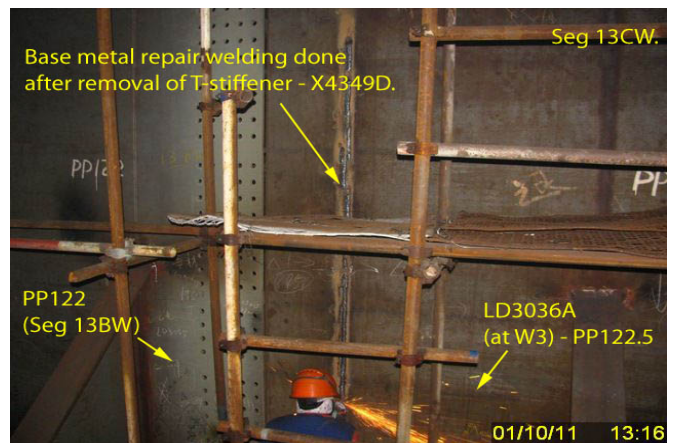
ZPMC personnel performing base metal repair welding on Longitudinal Diaphragm (LD) 3033A and LD 3036A at PP122.5. The welder is identified as 045196 and was observed welding in the 3G position. Welding process was identified as SMAW. ZPMC QC was identified as Wang Xiang Ping. Repair welding was done as per WRR: 19640 Rev-0. Base metal repair welding was done after the removal of T-stiffeners; X4314G (at W4) and X4349D (at W3). T-stiffeners were needed to be removed to perform alignment and drilling of splice plate at PP122 – PP122.5. See attached photo for further information.
